THE PORT AUTHORITY OF NEW YORK AND NEW JERSEY

To: August Preschle, Manager, World Trade Center Operations
From: Harry R. Pool, Jr.
Date: March 24, 1988
Subject: THE WORLD TRADE CENTER - ASBESTOS INVESTIGATION AND ANALYSIS REPORT
Copy to: F. Boyce, N. Budeiri, D. Darcy, J. Davison, D. Hahn, P. LaRocco, D. Leahy, R. Linn, P. Maurer, D. Moncalbano, J. Pearse, S. Samperi, V. Strom

ASBESTOS INVESTIGATION AND ANALYSIS REPORT
WORLD TRADE CENTER
VOLUME I OF II

ENVIRONMENTAL MANAGEMENT DIVISION
MARCH 21, 1988

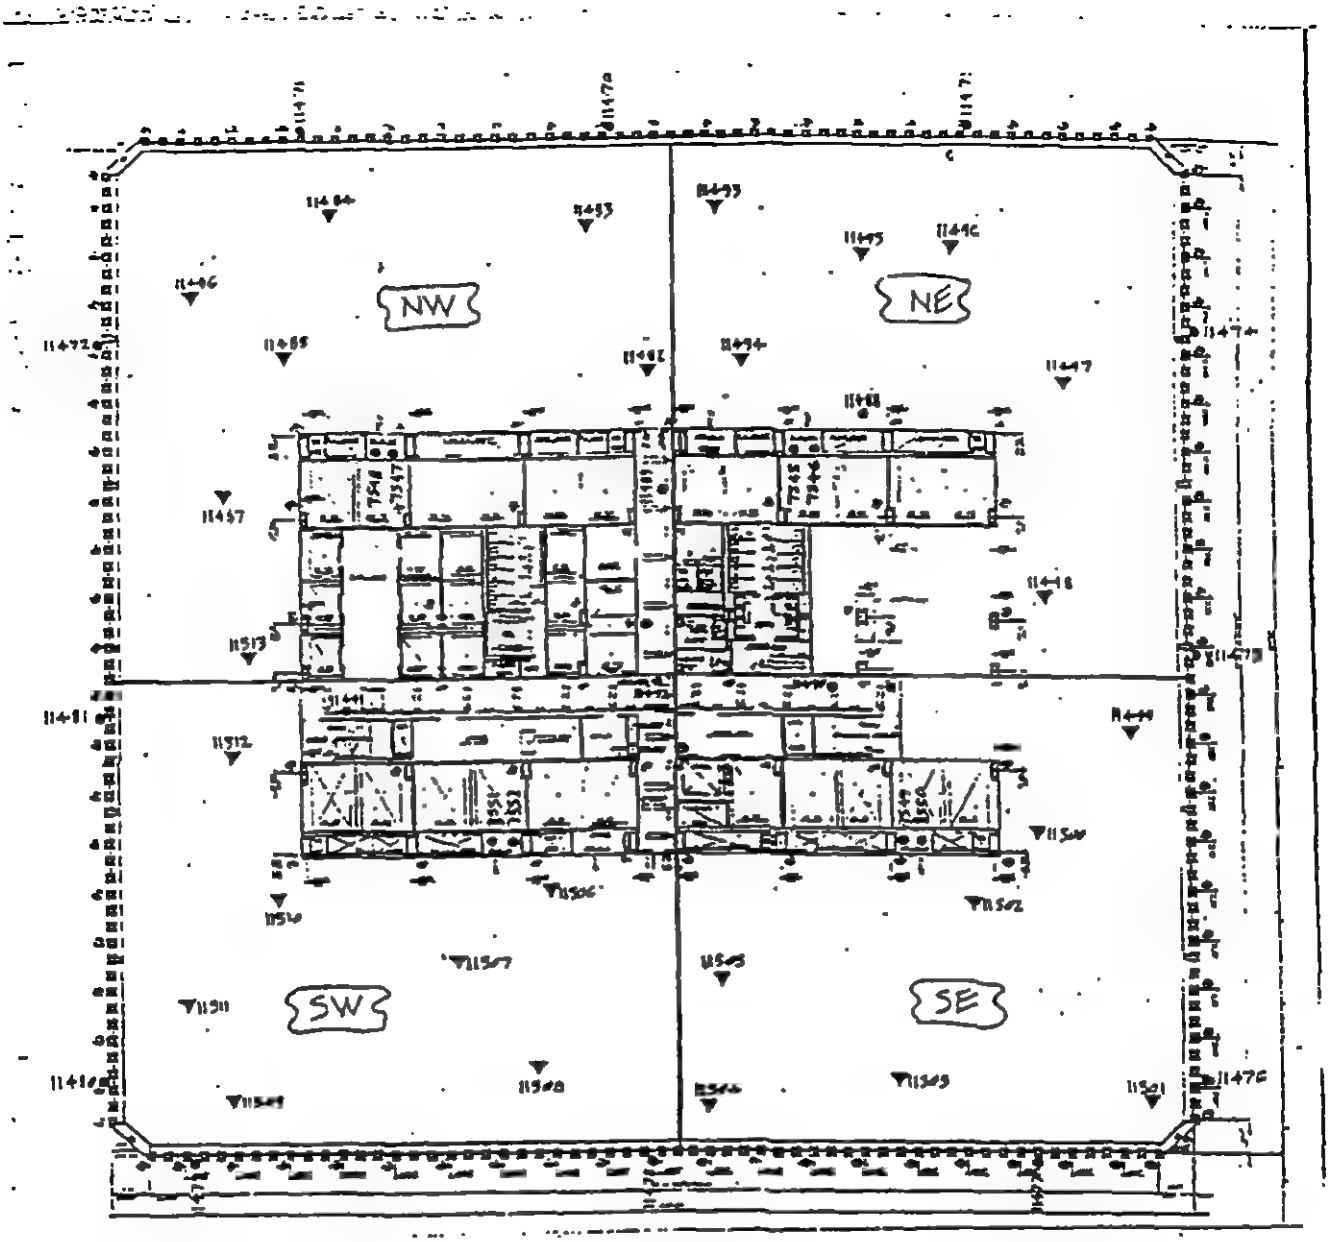
OPERATIONS AND MAINTENANCE AREA

THIS TYPE OF ASBESTOS CONDITION IS FREQUENTLY FOUND WHERE THE ACM IS USUALLY INSTALLED IN A LOCATION THAT IS NOT DIRECTLY ACCESSIBLE TO EMPLOYEES OR THE PUBLIC. HOWEVER, FOR OPERATIONAL OR MAINTENANCE PURPOSES EMPLOYEES MAY BE REQUIRED TO WORK IN CLOSE PROXIMITY AND INCREASE THE RISK OF DISTURBANCE TO THE ASBESTOS. IN THESE AREAS, WORKERS AND BUILDING OCCUPANTS MUST BE ALERTED TO THE LOCATION OF THE ACM AS APPLICABLE; PERSONNEL MUST BE TRAINED IN PROPER CLEANING, MAINTENANCE, REPAIRS, AND RENOVATIONS; AND ALL SUCH AREAS MUST BE PERIODICALLY REINSPECTED BY THE FACILITY.
